# Troubleshooting Err27.4

19 March 2024

**Panasonic Industry Co., Ltd.**  
**Industrial Device Business Division**  
**Motion Control Business Unit**

# Err27.4 Command Error

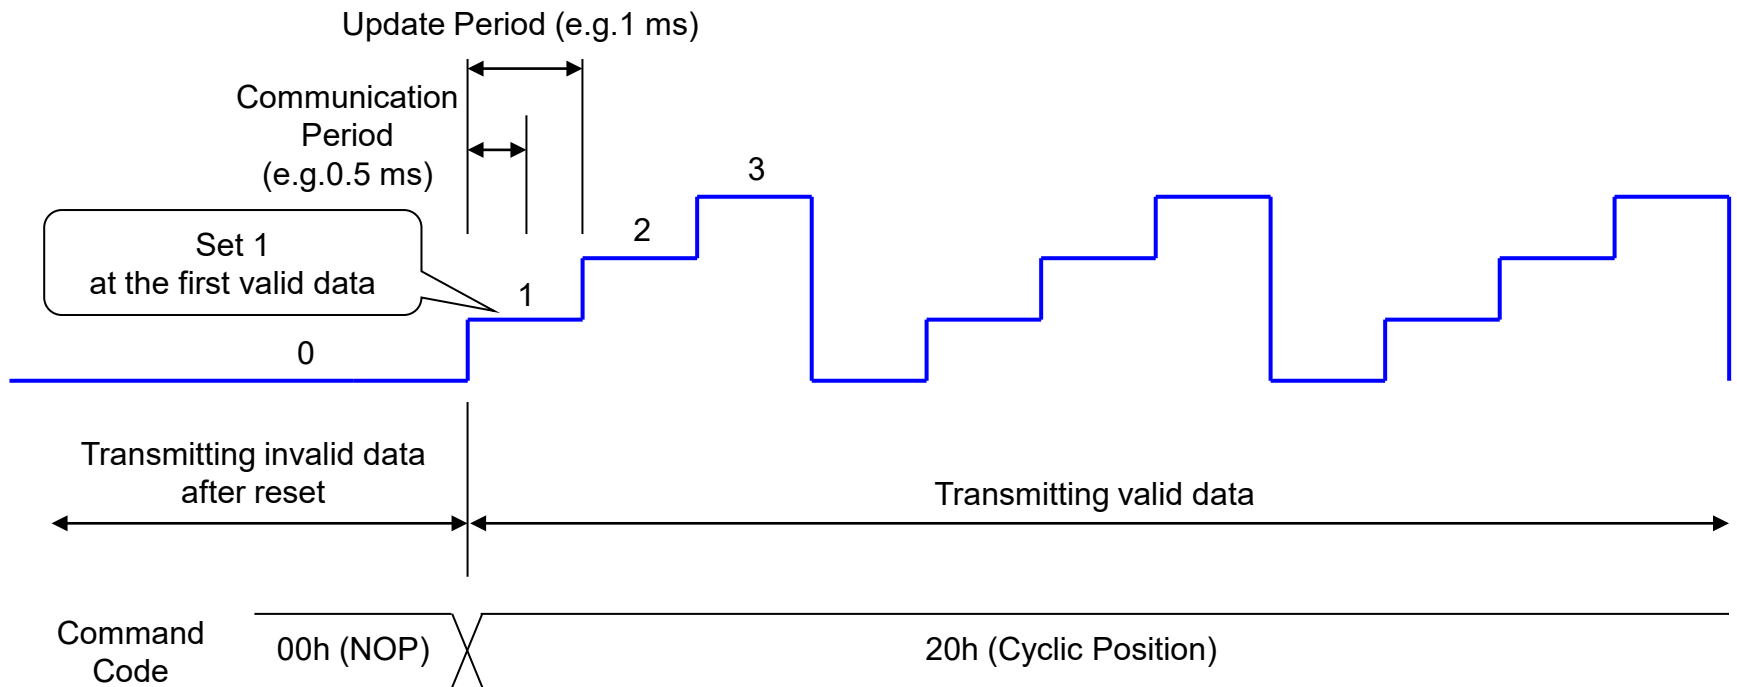
Update : Com. period = 2 : 1 case

The value counted up at the timing of command update must be set into Update Counter. Set 0 during invalid data transmitting after releasing reset, and set 1 at the first valid data. Subsequently, increment it as a free-run counter of 2-bit.

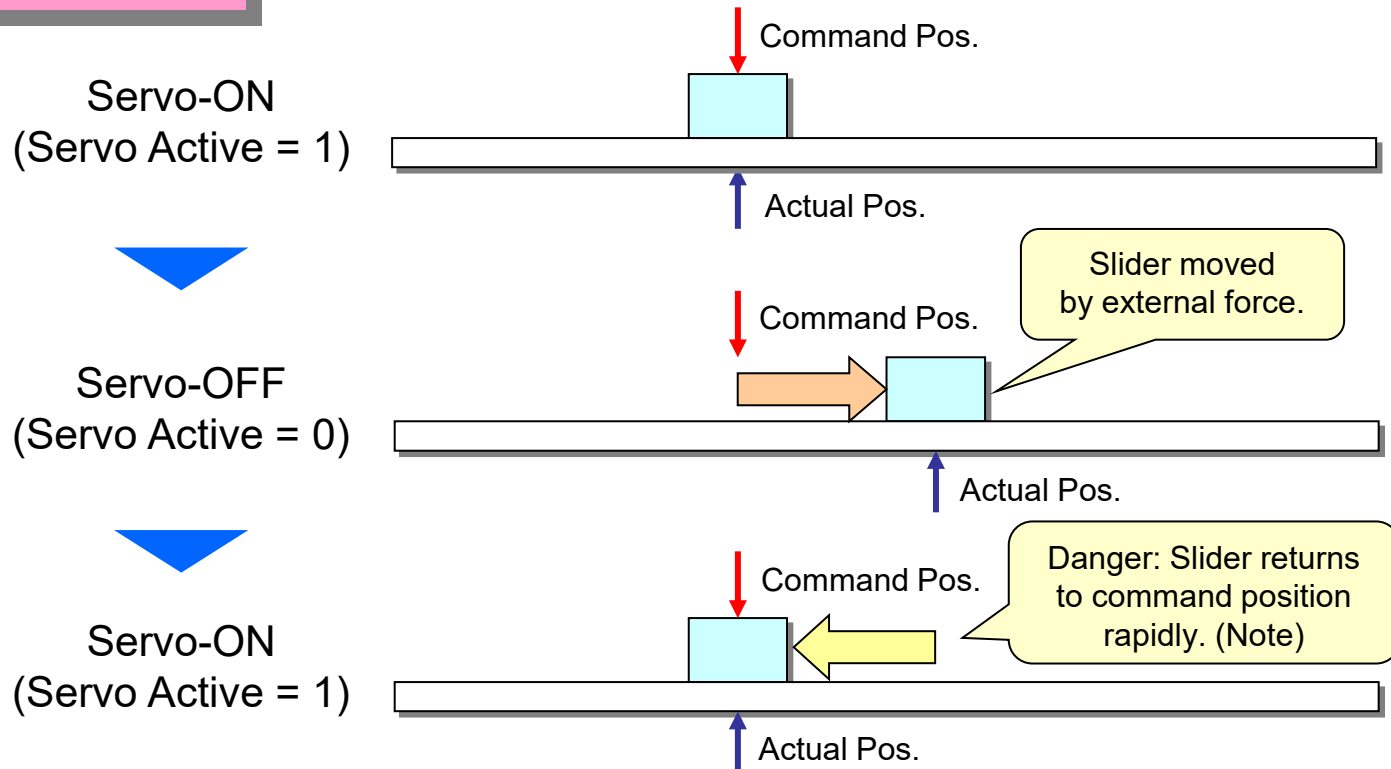
## Bad Example

While Servo Active is 0, the command position should be initialized with the actual position value periodically.

If not so, a danger motion may be caused when the actual position is moved by external force in servo-OFF. (Note)

**Note: There is Err27.4 case as well.**
