■ Troubleshooting Err84.0

Motor Business Unit
Automotive & Industrial Systems Company
Panasonic Corporation

Cause & Solutions of Err84.0 (Timeout)

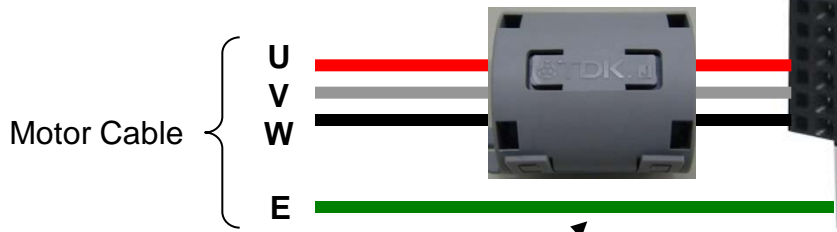
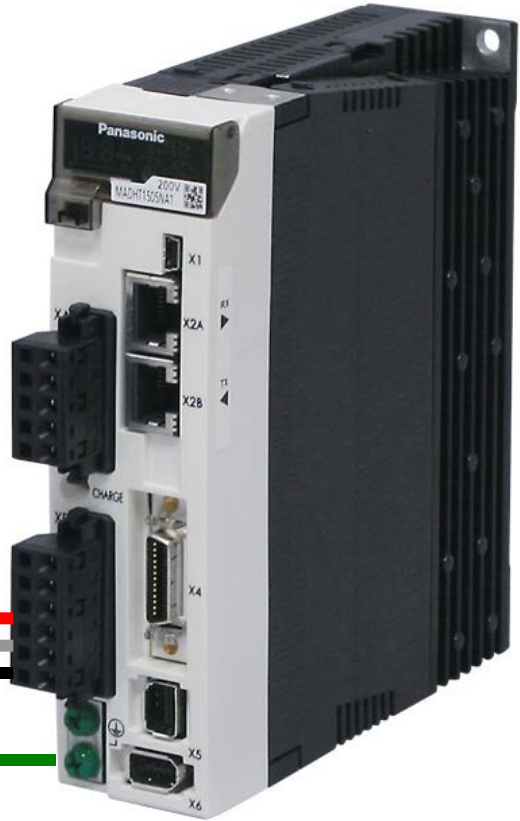
Reducing PWM Noise Radiated from Drive

Install a ferrite core on motor cable U, V and W.

Ferrite Core: ZCAT3035-1330 by TDK (DV0P1460)

Do not install it on E.
