# Troubleshooting Err27.4

19 March 2024

**Panasonic Industry Co., Ltd.**  
**Industrial Device Business Division**  
**Motion Control Business Unit**

# Err27.4 Command Error

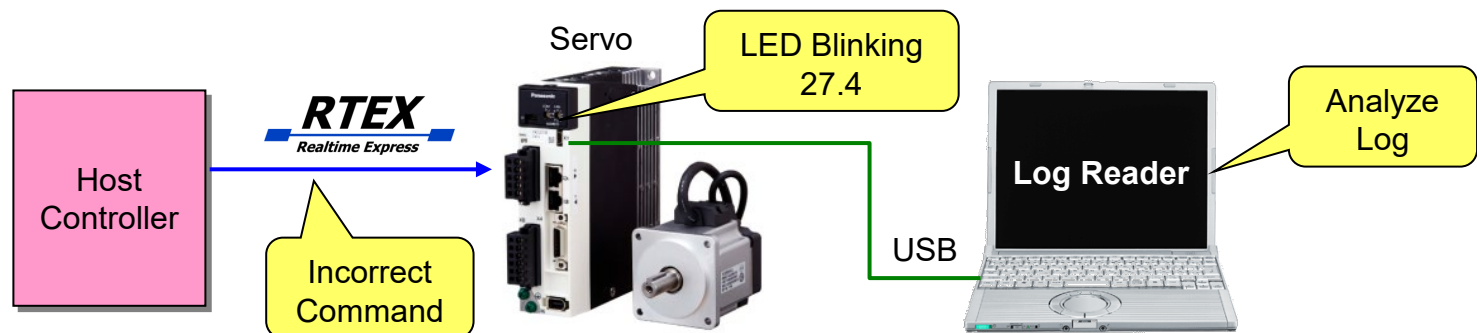
When Err27.4 occurs on correct parameter setting, there is a problem inside command data from a host controller to the servo. Using the tool "Log Reader", analyze a communication log data at the alarm.

Item	Description
Mode	Cyclic Position Control (Command Code: 2xh)
Detection	Too large change of command position
Cause Examples	Occurring in servo-ON: - Abnormal change of command position - Update counter incorrect Occurring at transit from servo-OFF to ON: - Command position not initialized during servo-OFF
Remedy	Correct command operation on software in the host controller.
